Ensuring a Foundation for Success

Correct Installation of Baseplates

By: John Hayward
President
Hayward Gordon Ltd.

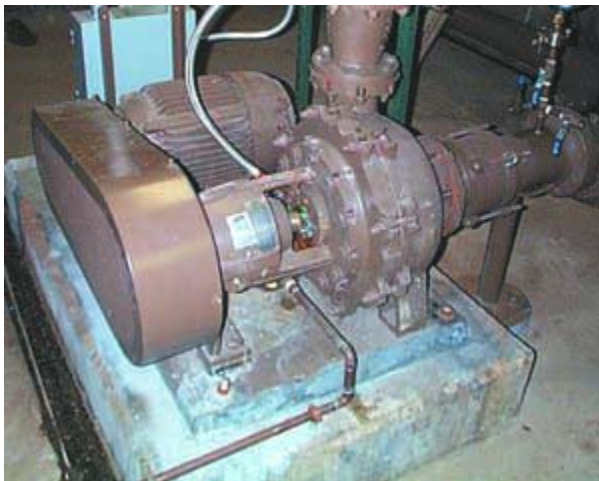
Figure 1: Well Grouted Pump

The objective of grouting is to completely bond the baseplate to the foundation so that a single block of support is created with sufficient mass to provide effective vibration dampening. It is very important that the grout completely fills the cavity beneath the baseplate. Voids, which can result from the presence of air pockets or from "settlement shrinkage" of over-watered grout, can lead to baseplate resonance. In one recent installation such voids were the direct cause of baseplate and pump vibration levels that exceeded twice the acceptable limits. Once the foundations were repaired by the contractor, vibration levels plummeted and the chronic bearing and seal failures being experienced were eliminated.

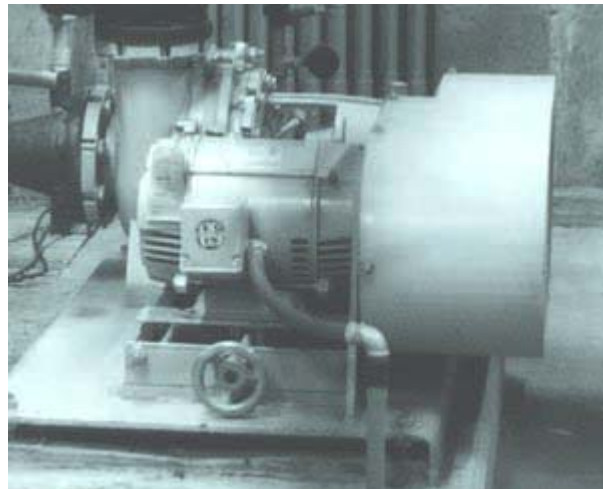
Figure 2: Poorly Grouted Pump
